JEFFERSON COUNTY ECONOMIC DEVELOPMENT CONSORTIUM (JCEDC) BOARD AGENDA

Stabilization/demolition options for Sauk City RR Bridge

for

Wisconsin River Rail Transit Commission

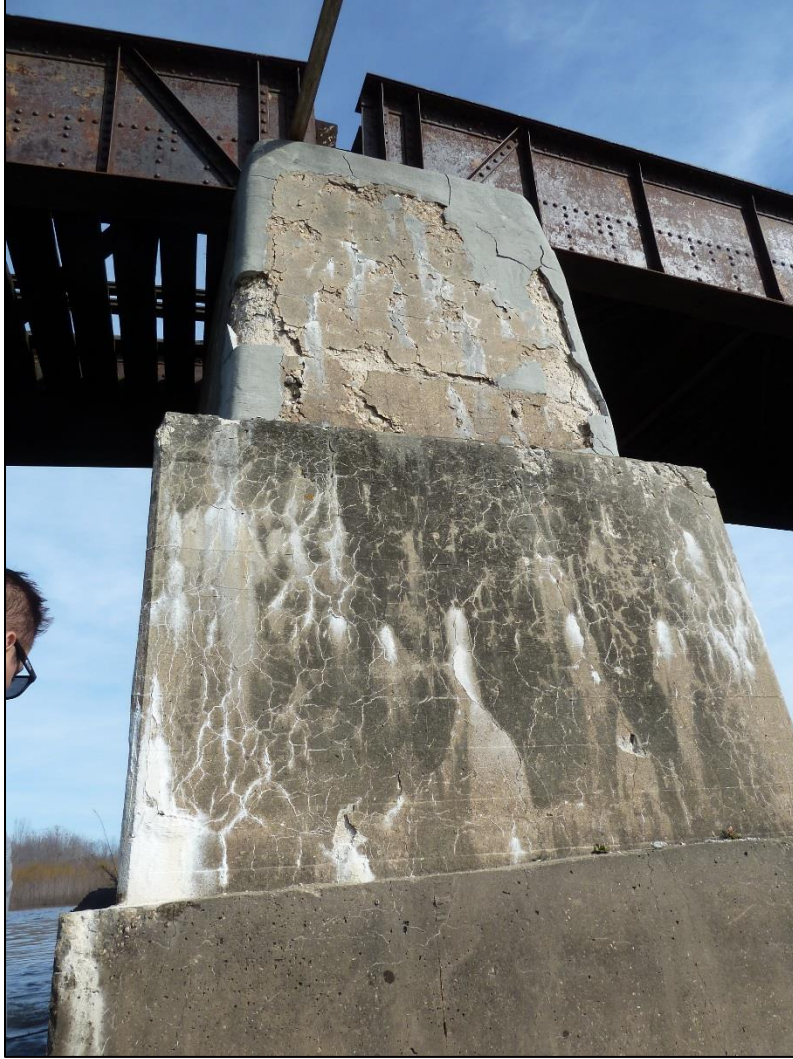
- Concrete shaft—top of shaft appears to have been patched, but has spalls up to 1 ft in size. Surface cracks and efflorescence over approximately 40% of the mid-section (see Figure 1). Exposed rebar and honeycombing found at/below waterline. Concrete below waterline is sound when struck with hammer.

Element	Condition
Concrete Shaft/Seal	5
Timber Piles	6
Scour	3
Overall condition	3—Serious Condition

Figure 1: Pier 1 shaft, downstream face

Although the condition of Pier 1 is serious, it is stable. However, it is at risk of further scouring and requires corrective action. Westbrook recommends placing heavy riprap up along the west and downstream faces. Depth of placement should be 9 ft deep near the nose and taper down to 3 ft at the tail. Note that even with corrective action, the current will continue to strike the pier at a high angle of attack creating a turbulent flow. The streambed condition should be monitored on at least a 5-year inspection cycle to check for scour. With these measures, stability could be maintained. While stability may be maintained for the current dead loads, it is questionable whether the pier can be made suitable for future service live loads.

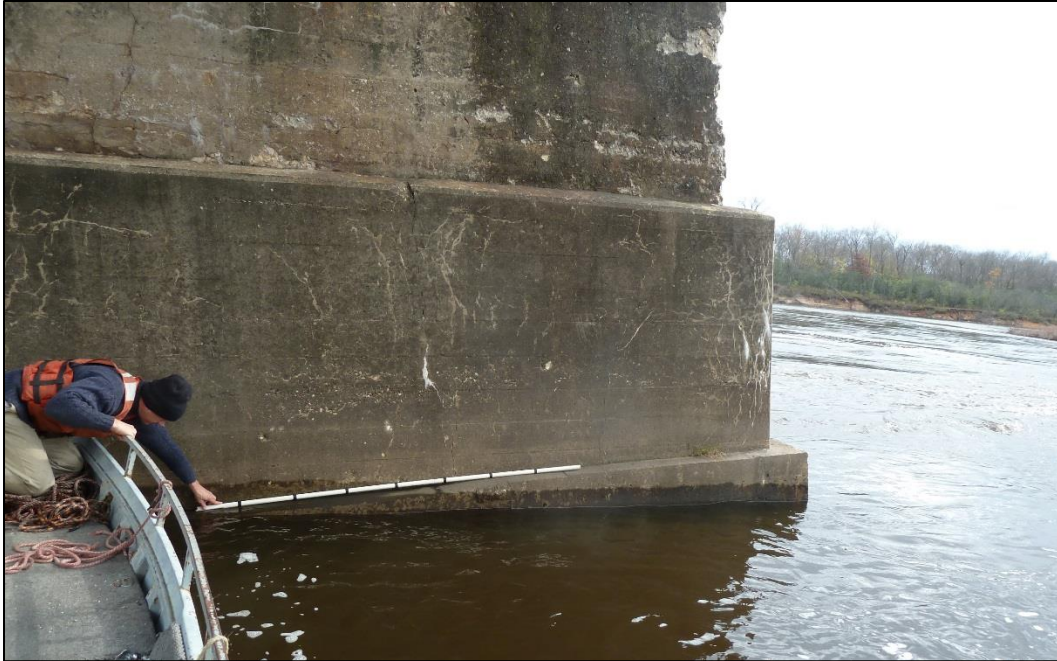
Element	Condition
Concrete Shaft/Seal	5
Timber Piles	not observed
Scour	0
Overall condition	0—Failed Condition

Figure 2: measuring pier rotation

As stated previously, Pier 2 is in a failed condition due to scour, or undermining, of the foundation concrete and supporting piles. The extent of settlement and rotation is such that corrective action is not feasible. Although it remains standing, the stability of the pier is questionable. A flood or high flow event could further scour the river bed material under the pier leading to a collapse of the pier, Span 2, and Span 3. Should this happen, the area of the material blocking the river flow could hasten scouring action at Piers 1 and 3. Pier 1 in particular is already undermined and would be sensitive to additional scouring.

For these reasons Westbrook recommends removing Pier 2 along with Spans 2 and 3. This action should be considered urgent and it is recommended the removal take place before potential spring flooding. Stabilizing Pier 2 could be an alternate option to consider, however it is not recommended. Placing heavy riprap or construction of a sheet pile cell around the pier could provide stability, but each has drawbacks. There is evidence that Pier 2 was previously protected by riprap, so replacing it would be a temporary measure at best. Constructing a sheet pile cell around the pier would further restrict river flow exacerbating scour issues.

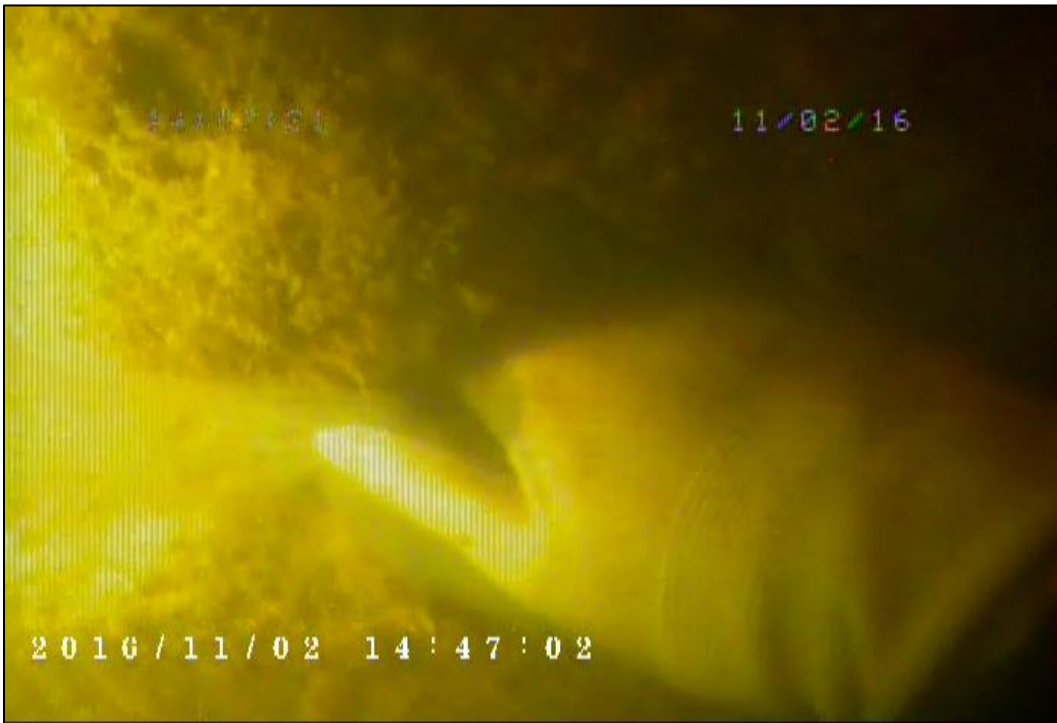
- Concrete shaft—surface cracks, efflorescence, and edge spalls < 6 inches. There is a diagonal crack on east face which starts at bridge seat and proceeds down to left side. Below the waterline, the joint between the shaft and the seal is open up to 2 inches. It appears to be due to poorly consolidated materials. The diver can probe in about one hand's depth (see Figure 3).

Figure 3: open construction joint. Diver's hand is shown inserted into joint.

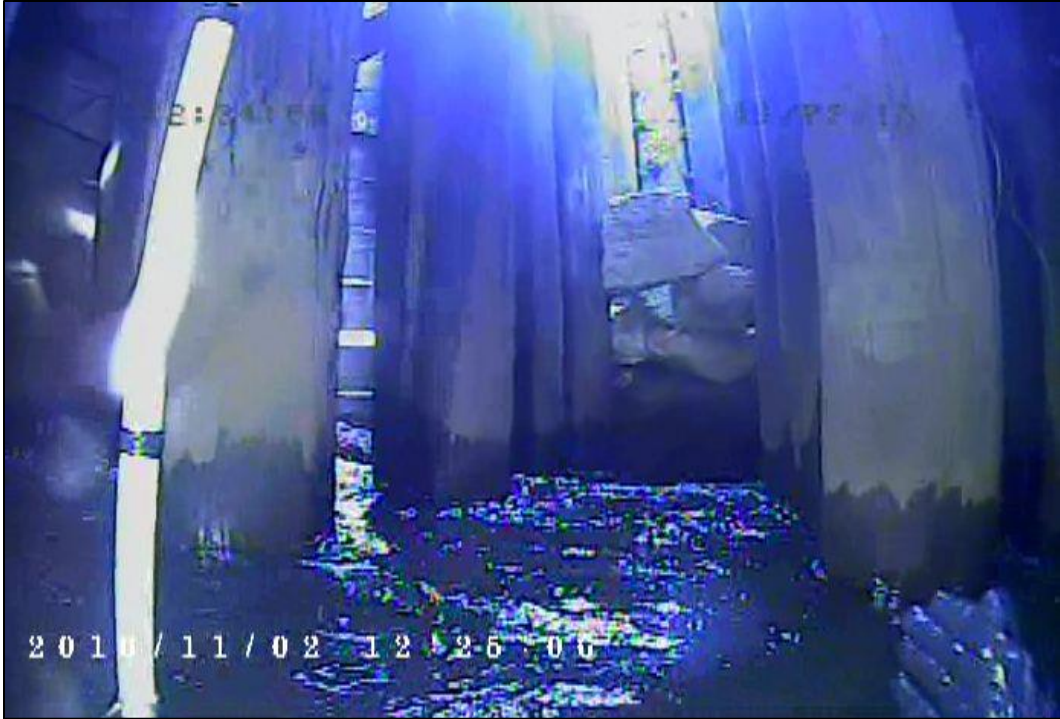
- Streambed/scour—the pier is heavily riprapped along the west and downstream sides. Rocks as large as 3 ft were found. The area inside the perimeter boards was also filled with riprap (see Figure 4). The height of riprap placement inside the pier is typically a few feet higher than riprap observed outside the pier. It is assumed that the east face is also covered with riprap since no current was felt flowing through the piles. However, there was water flowing through the piles and perimeter timbers at the nose. Riprap at the tail of the pier was mixed with sand deposits.

Figure 4: riprap placed inside pier at nose

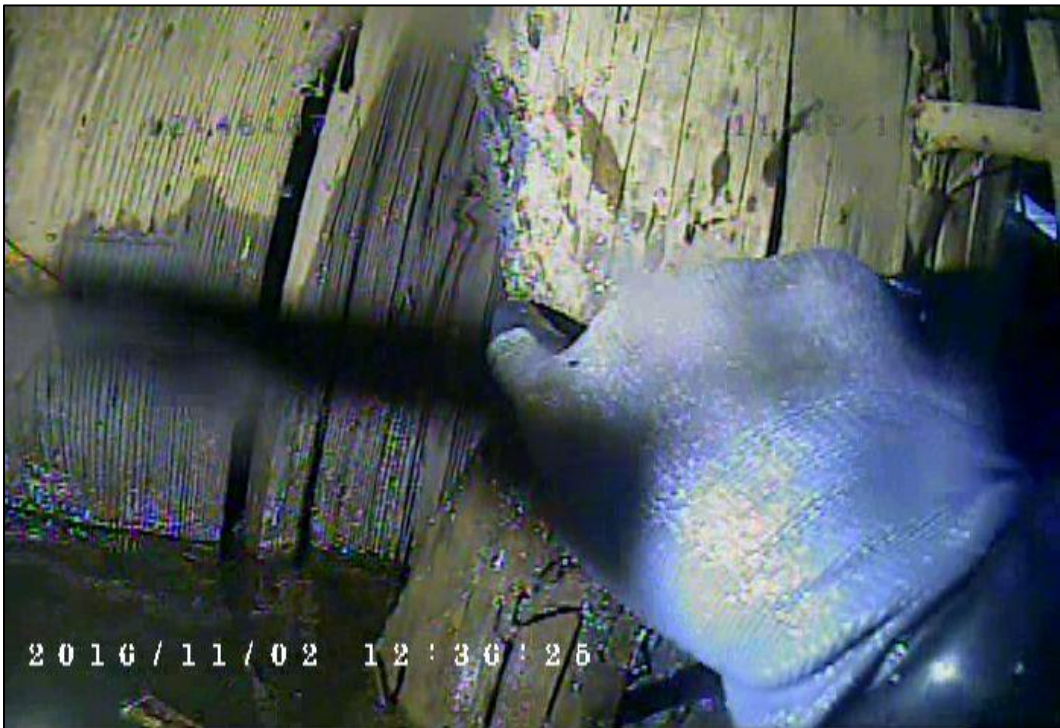
- Timber piles—generally plumb. The easternmost row of piles are abraded at/below the waterline and have 25–50% section loss. This abrasion must have occurred prior to the installation of the perimeter boards (see Figure 5). In addition, the two downstream piles in this row were broken off below the waterline. The three remaining pile rows are generally sound. From the water line down, these have soft or separated fibers up to ¼” deep. With the outer fibers removed, the timber is sound when struck with a hammer.

Figure 5: abraded pile, east side of pier

The condition of Pier 3 is poor due to the condition of timber piles along its eastern face, but the pier is stable. No action is necessary to maintain stability at this time. To make the bridge serviceable, Westbrook recommends reconstructing the southeast corner of the pier where the diver found two broken timber piles, and placing a layer of riprap 2–4 ft thick around the perimeter to enhance scour protection. Consider this the minimum action necessary. Depending on the intended load, a reconstruction of the easternmost row of piles may be warranted. In addition, the condition of the streambed and timbers should continue to be monitored.

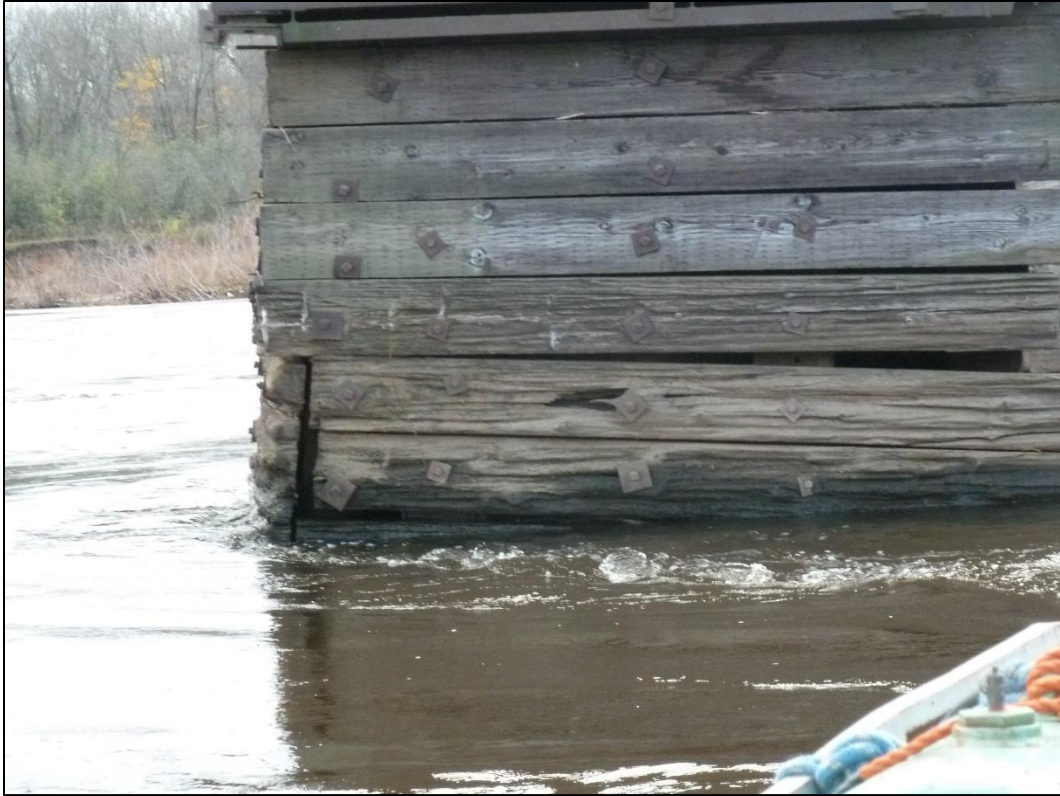
- Timber perimeter boards—timbers are out of level which makes the pier look “racked” or settled; however, piles and cap beams are generally plumb and level, respectively. Some of the attachment hardware is loose or disconnected. Timbers are generally sound except for at the nose where they are abraded at the waterline (see Figure 6).

Figure 6: condition of perimeter timbers at nose

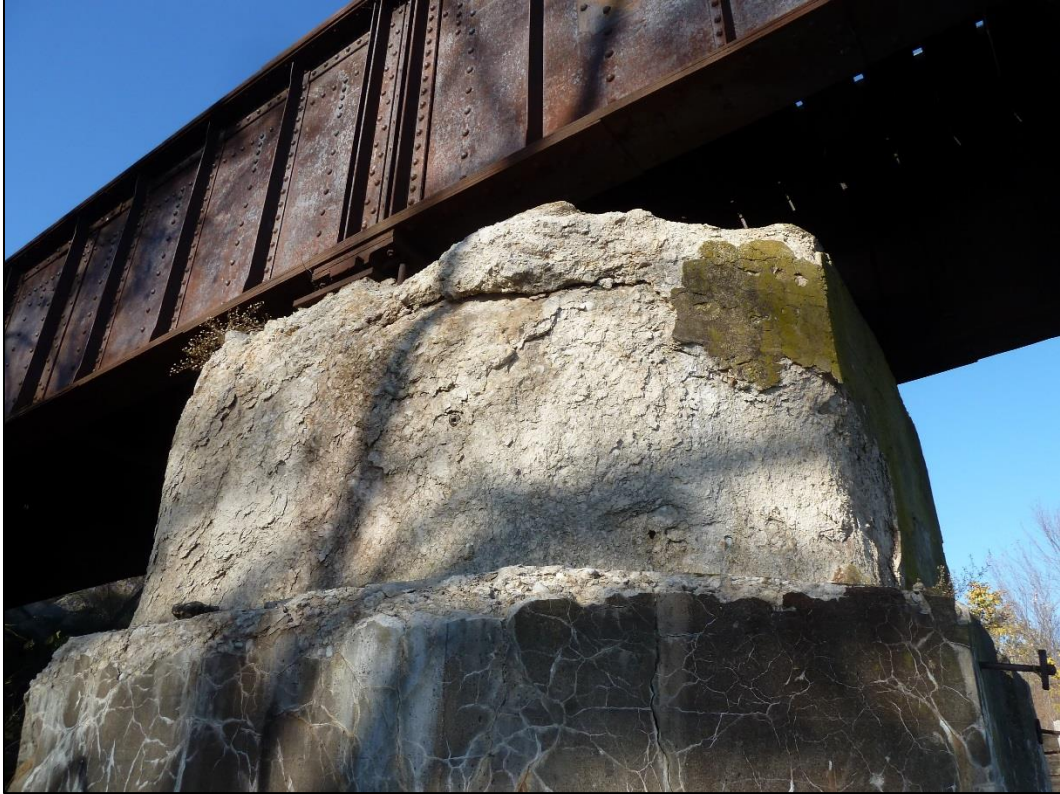
Element	Condition
Concrete Shaft	4
Steel Sheet Piling	6
Scour	7
Overall condition	4—Poor Condition

Figure 7: Pier 5 shaft, downstream face

The condition of Pier 5 is poor due to the condition of the concrete shaft, but the pier is stable. No action is necessary to maintain stability. To make the pier serviceable, concrete surface repair or an encasement of the existing shaft is recommended. Either action must include removing loose and delaminated concrete down to sound concrete and anchoring in new reinforcement.

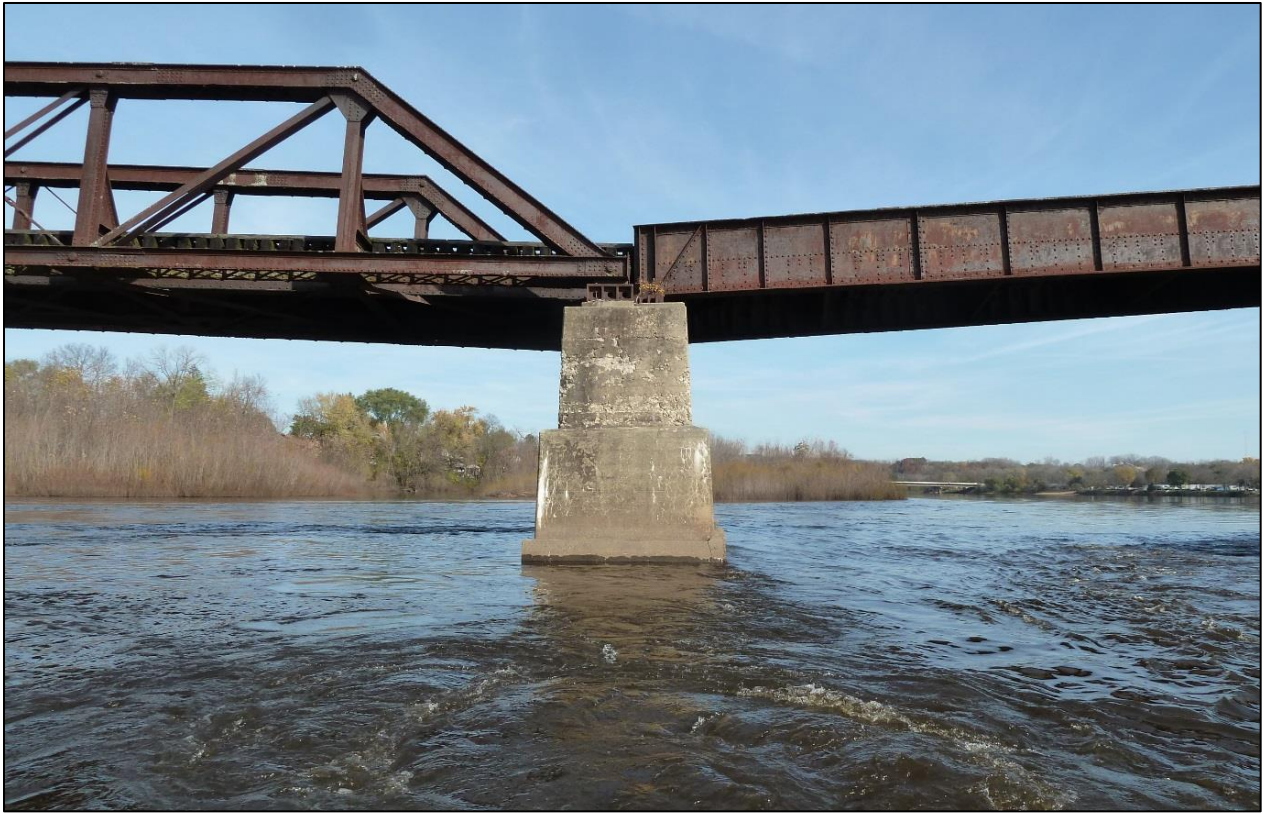
Photo 3: Pier 2 facing upstream

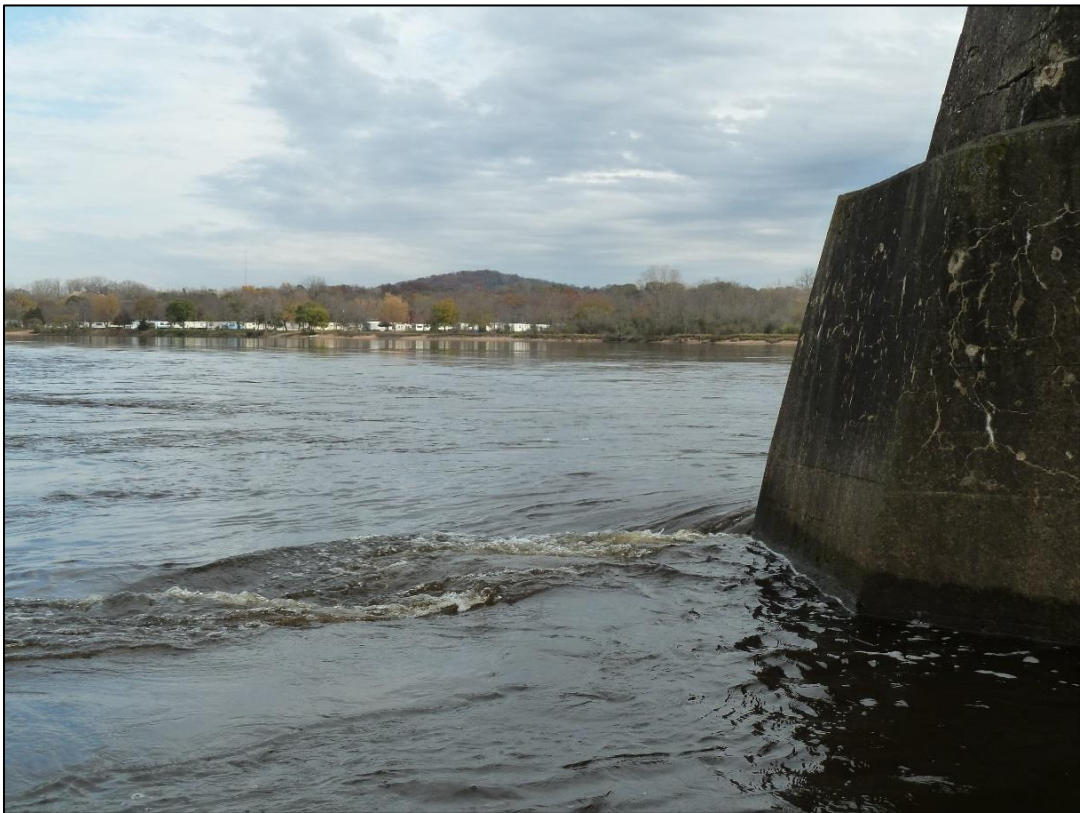
Photo 12: Pier 2, eddy formed west side of nose
