Trail Bridge UW Inspection Report

To: Jefferson County

Inspection Date: 05/06/2022

Location: Trail Bridge over the Rock River. 0.6 Miles East of CTH F

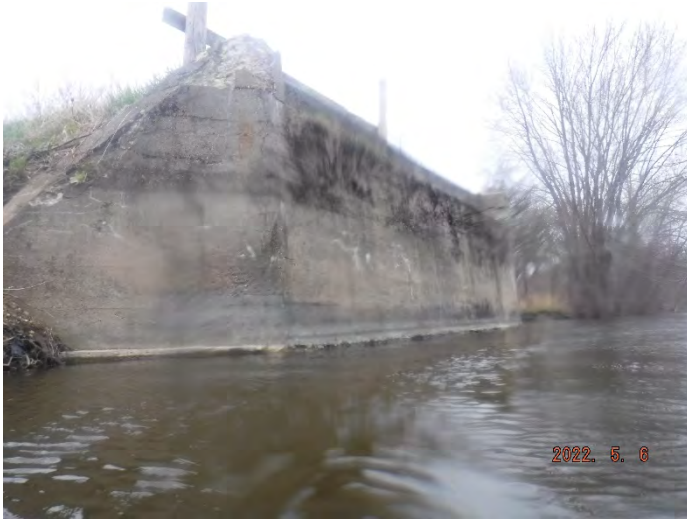
West Abutment

West Abutment: Has cracking throughout with efflorescence. No undermining observed. Abutment in fair condition.

-Recommend placing heavy riprap at abutments and pier to prevent scour or undermining.

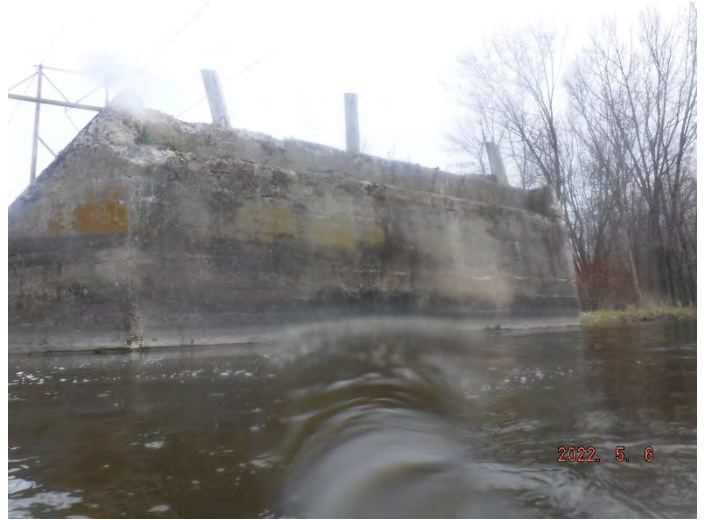
East Abutment

East Abutment: Cracking throughout with efflorescence. Areas of spalls and deterioration at ends. No undermining observed. Abutment in fair condition.

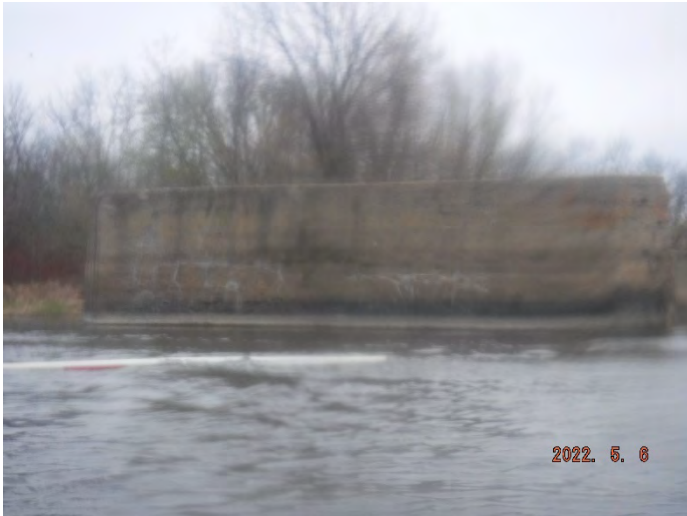
West Face of Pier

Pier: Has map cracking throughout with efflorescence. Footing with vertical exposure of up to 2.5 feet. No undermining observed. Footing does have minor spalling throughout. Pier is in fair condition.

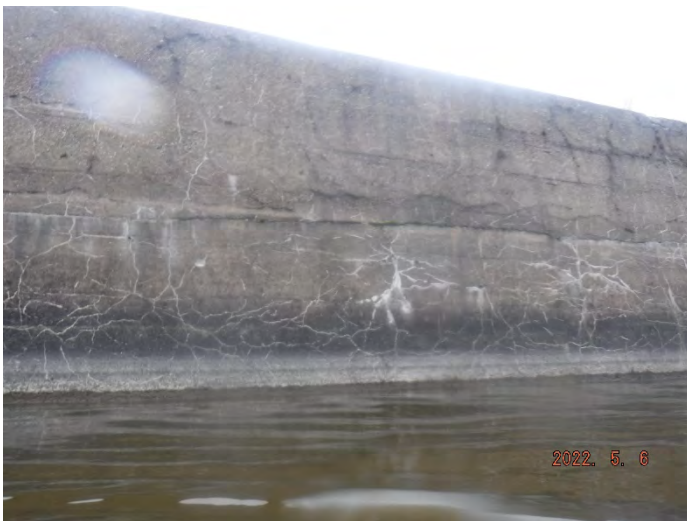
Typical Map Cracking with Efflorescence at Pier

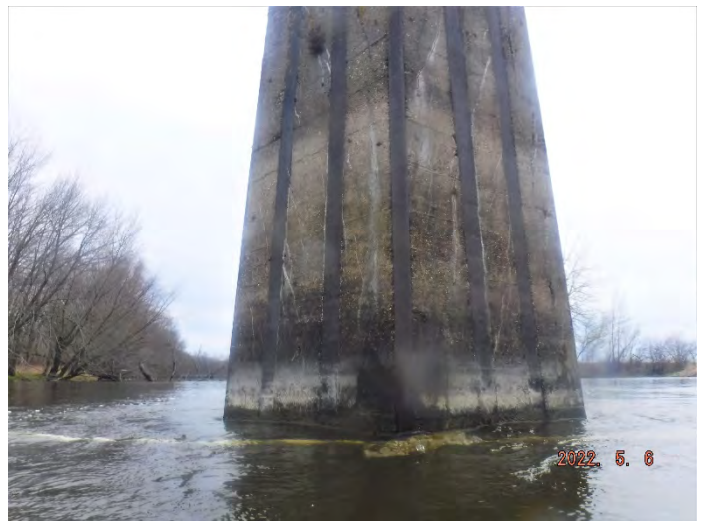
Upstream Nose of Pier Vertical Cracks

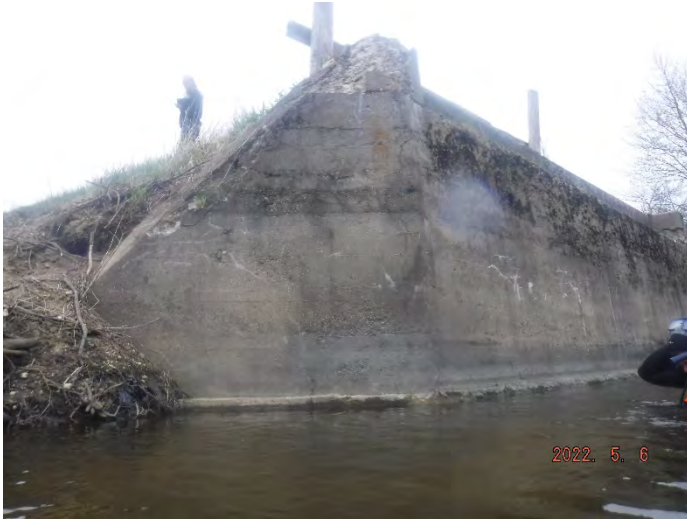
Wingwalls: Cracking through with areas of spalling. Wingwalls in fair condition.

West Abutment South Wingwall Deterioration

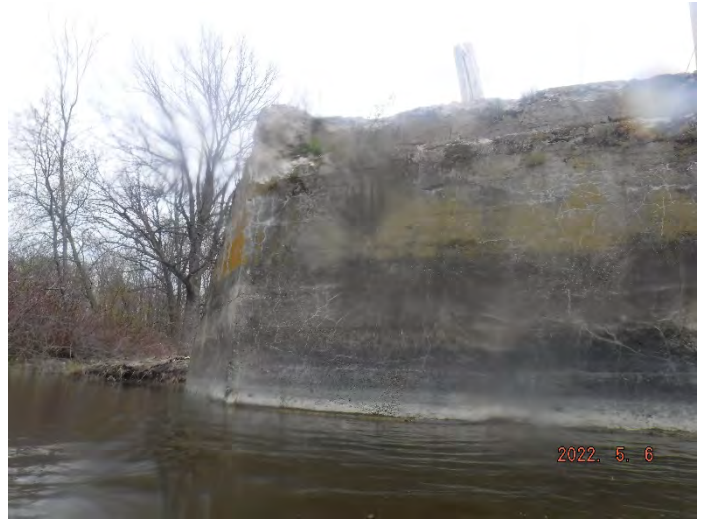
Map Cracking/Spalling at East Abutment

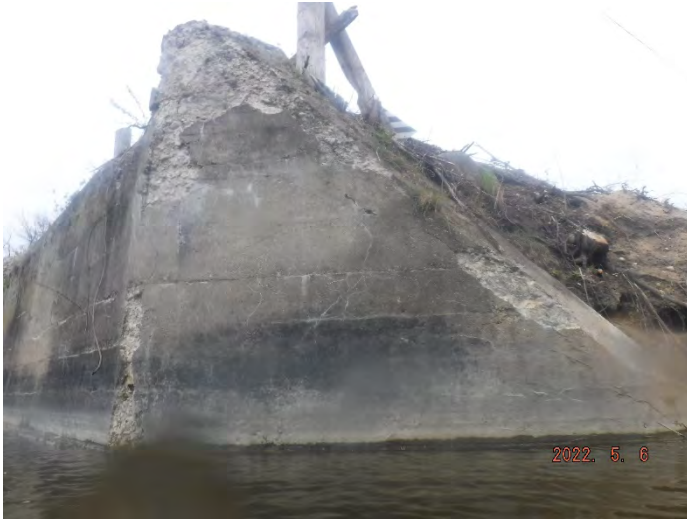
East Abutment South Wingwall Deterioration

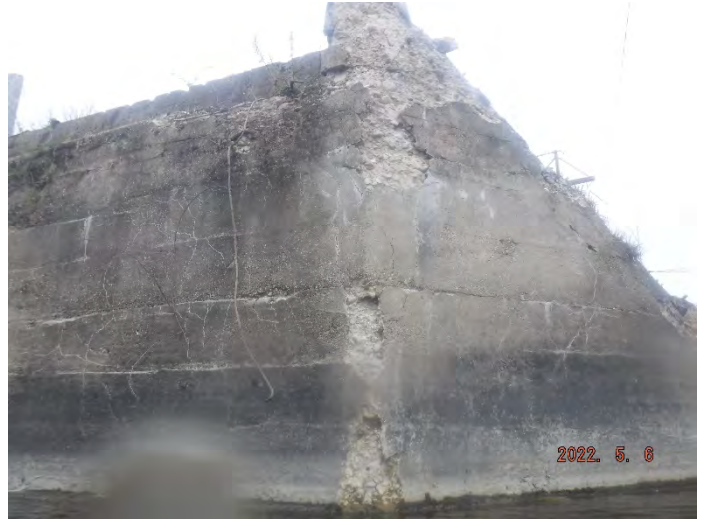
East Abutment South End Spalling
