JEFFERSON COUNTY ECONOMIC DEVELOPMENT CONSORTIUM (JCEDC) BOARD AGENDA

Stabilization/demolition options for Sauk City RR Bridge

for

Wisconsin River Rail Transit Commission

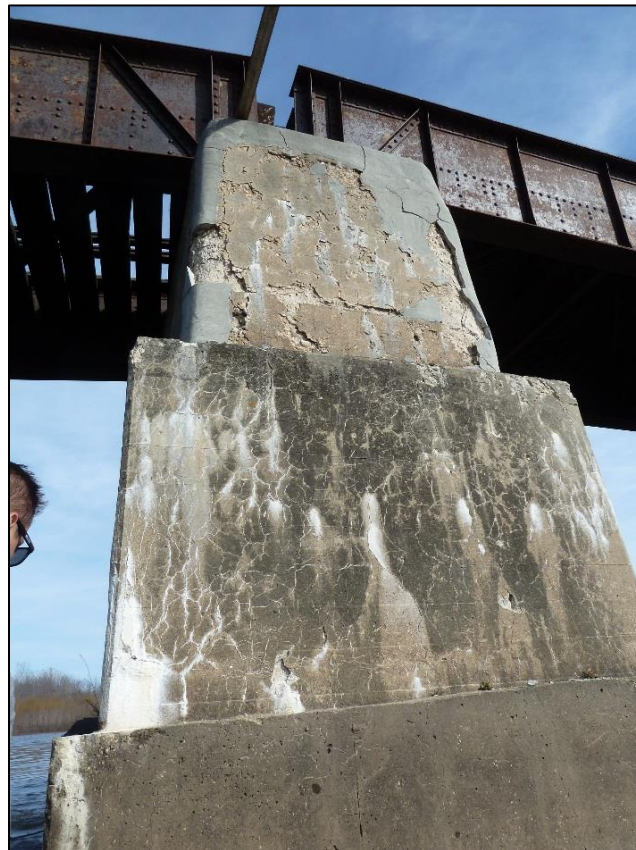
Photo 8: Pier 1, downstream face

- Concrete shaft—top of shaft appears to have been patched, but has spalls up to 1 ft in size. Surface cracks and efflorescence over approximately 40% of the mid-section (see Figure 1). Exposed rebar and honeycombing found at/below waterline. Concrete below waterline is sound when struck with hammer.

Install heavy riprap along west and downstream faces of Pier 1. Jack up and stabilize Pier 2, reset Spans 2 & 3 on Pier 2. Eliminates safety hazard and keeps all components in place for future recreational trail. Estimated cost \$1,550,000. Presents a myriad of challenges. Assumes sealing scour at Pier 2 with sheet pile and removal of top 4-5' section of Pier 2, then re-casting top section for span bearing. Jacking of Pier 2 doubtful.

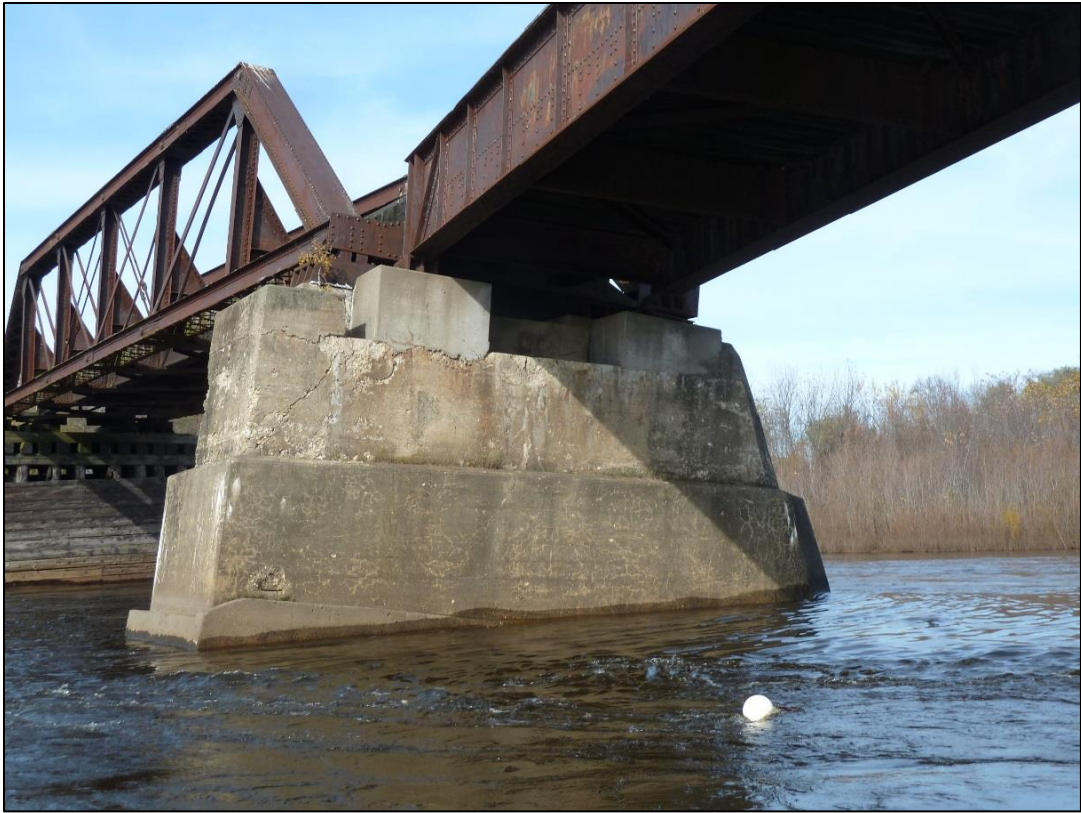
Photo 9: Pier 2, east face

- Pier has settled and has rotated to a slope of 10:1 (see Figure 2).
- Stream alignment—current strikes the pier along the east side at a high angle of attack. Flow is turbulent at nose and tail.

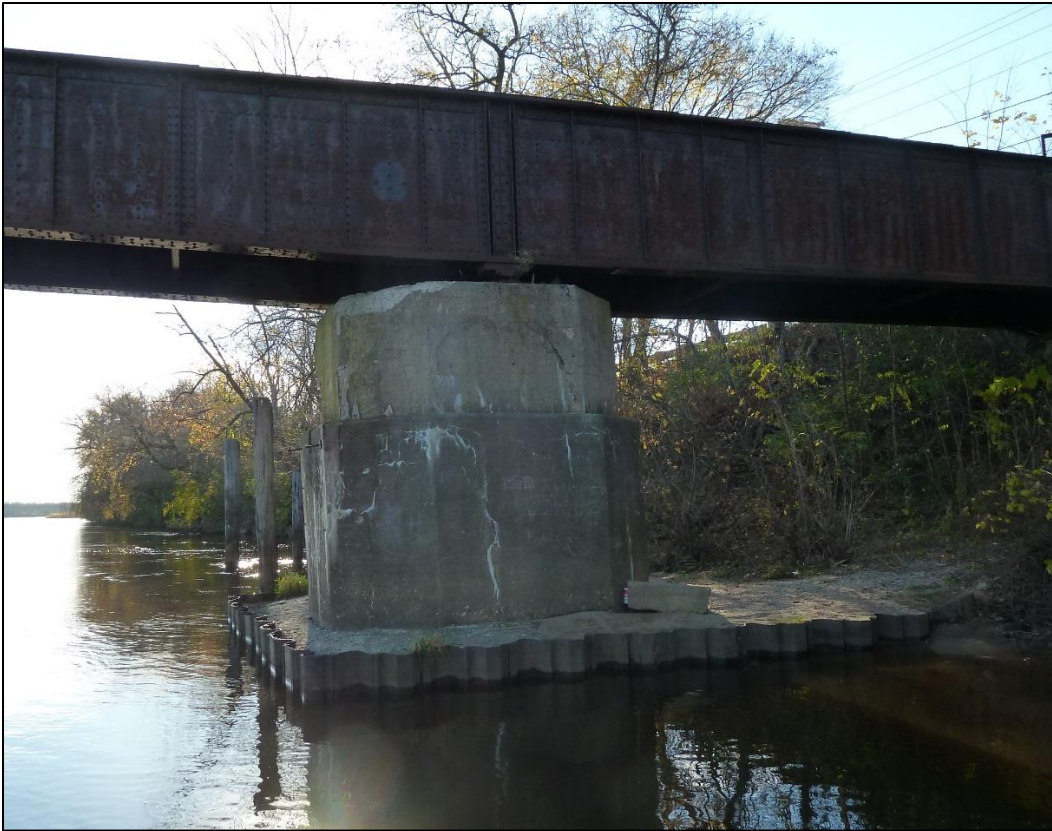
Photo 17: Pier 5, upstream face

- Stream alignment—the pier is protected by a sandbar/river bank upstream. Calm current.
- Streambed/scour—the streambed consists of sand with concrete rubble and stone up to 1 ft in size. No evidence of scour, all steel sheet piles penetrate the streambed.
- Concrete shaft—Surface cracks and efflorescence over approximately 50% of the shaft area. The downstream side has spalls and delamination over half the face (see Figure 7).
- Steel sheet piles—sheet piles have surface rust and scaling. With the rust removed, the steel surface is pitted up to 1/16-inch. All sheet pile interlocks are tight and intact.
- Timber piles—there is an old timber wing dam upstream of the pier and timber fender piles downstream of the pier. These were not inspected.
- Debris/drift—none

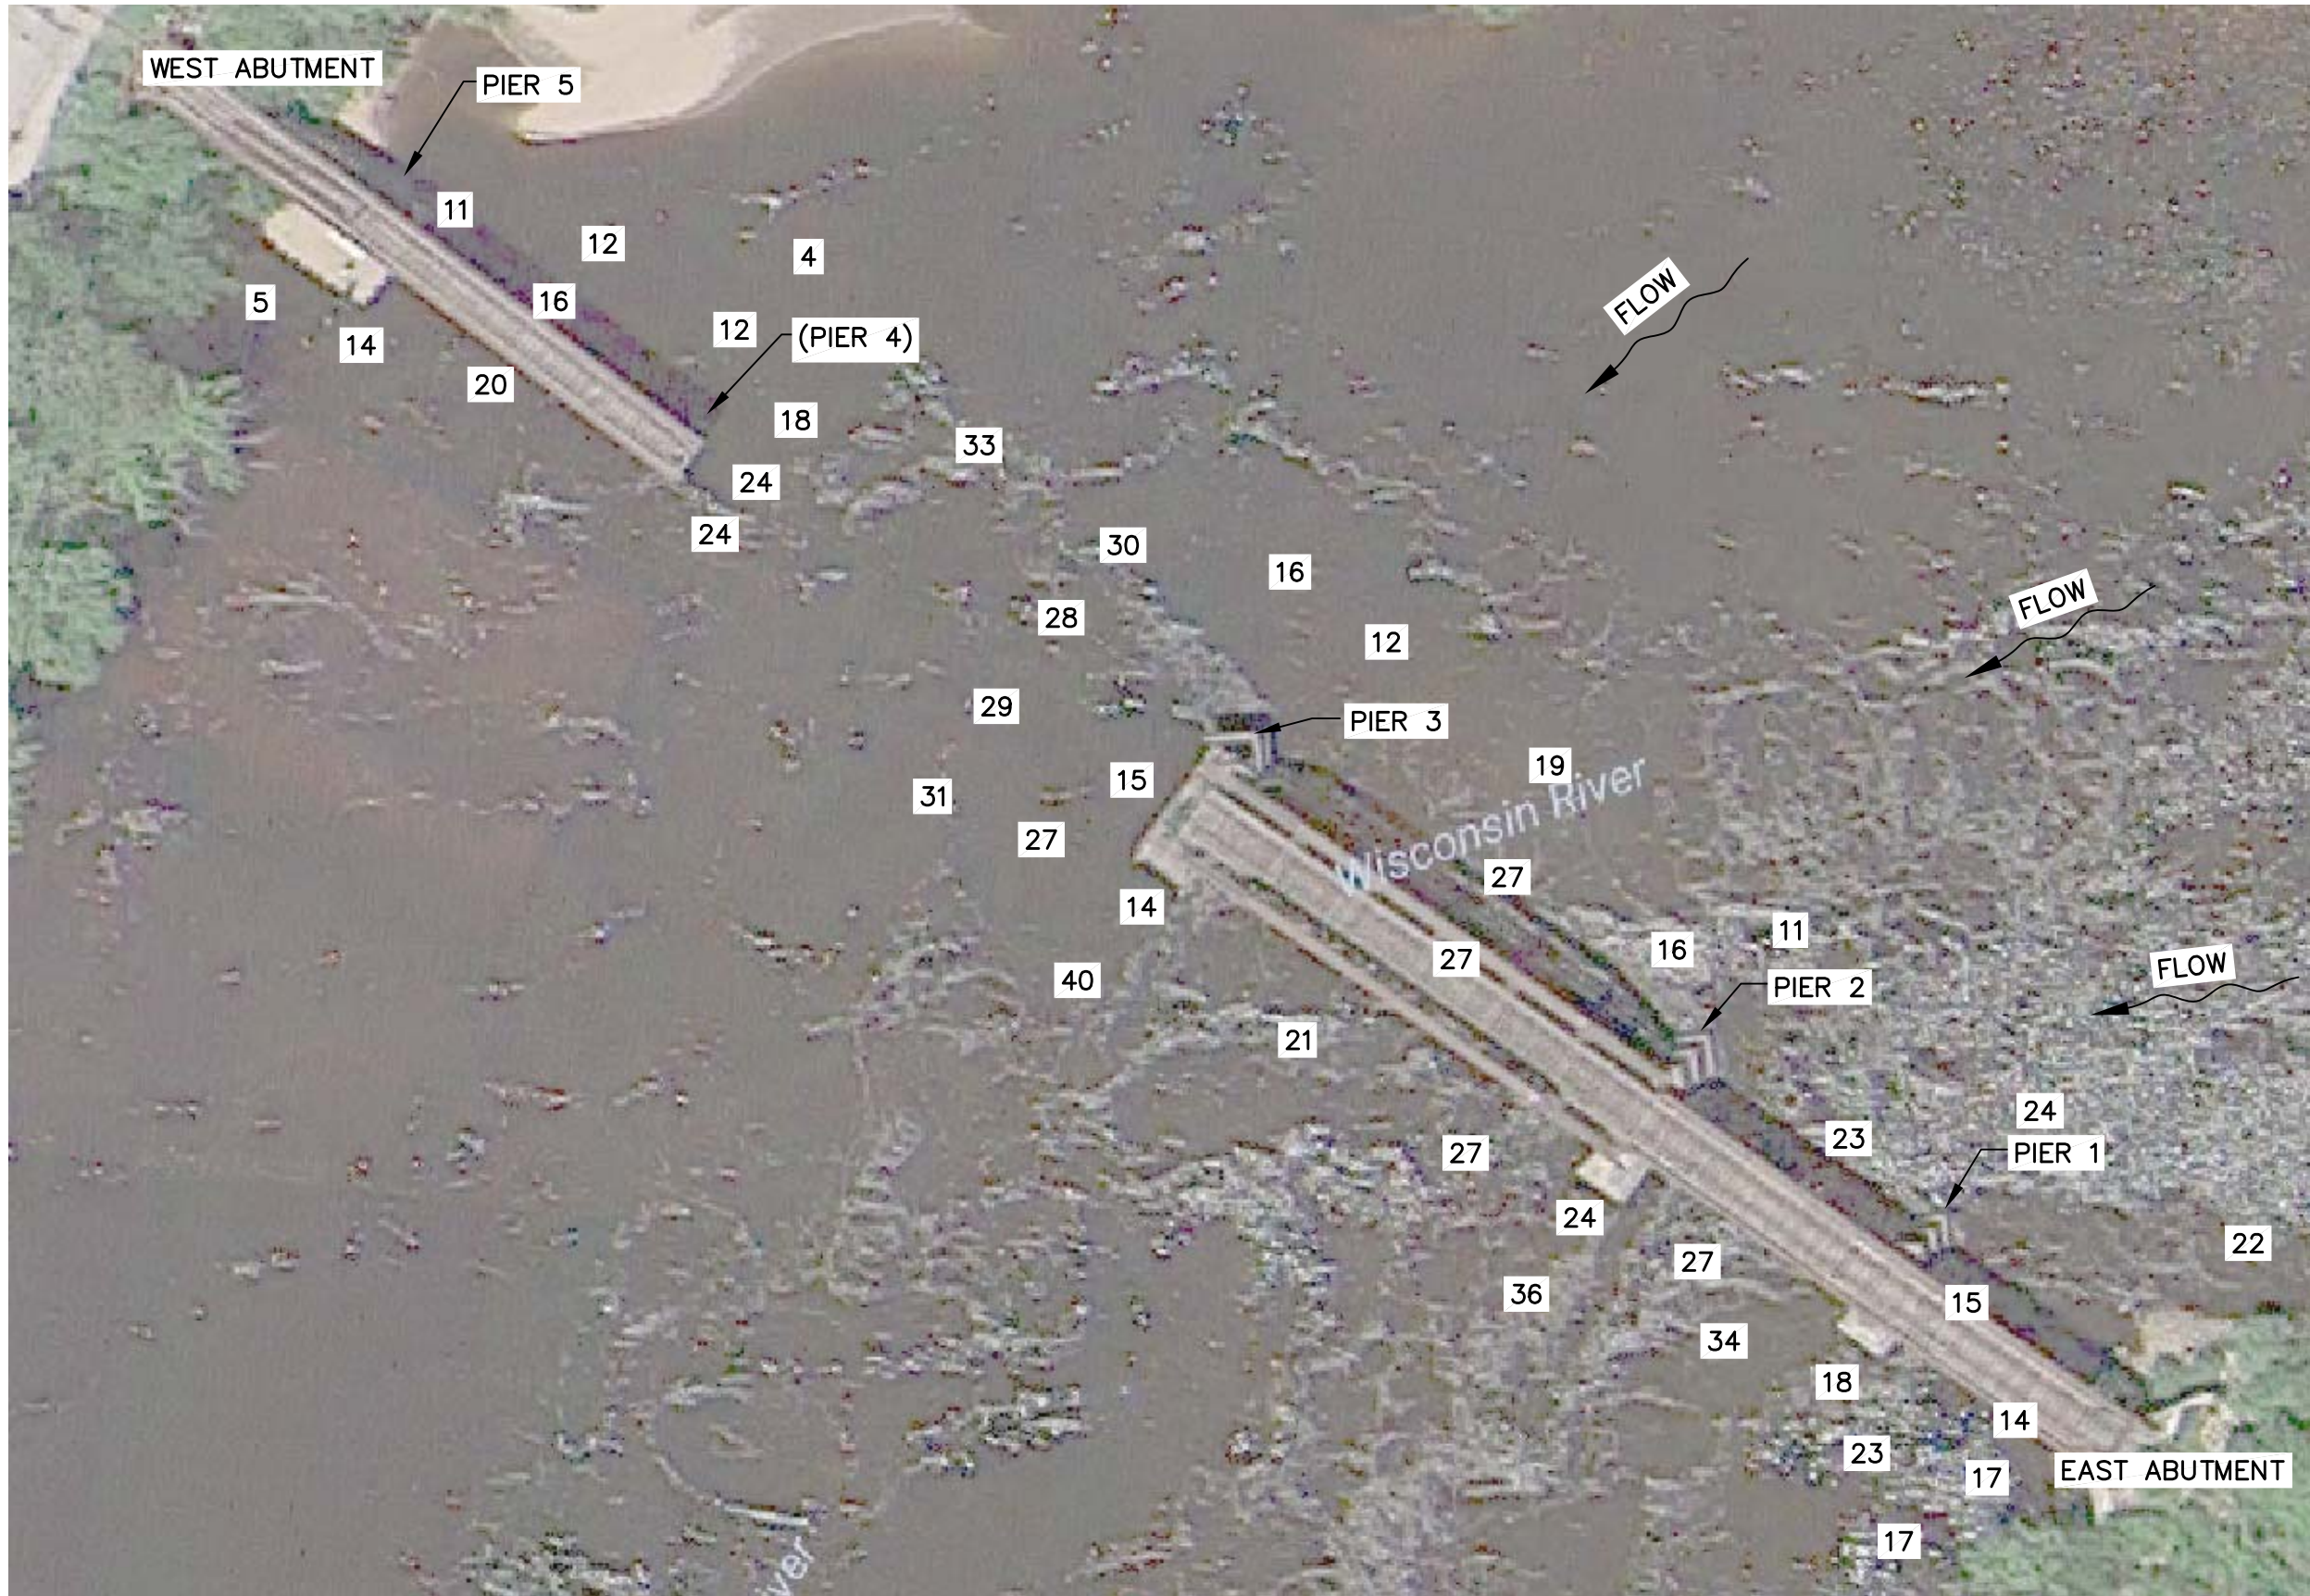
Exhibit E
Water Depths

MEASURED 11/2/2016 USING A SONAR DEPTH FINDER
CALIBRATED WITH A WEIGHTED TAPE.
